Manhole Inspection Summary

Manhole # S35C__058MH

Insp Date: 11/14/08 12:23 PM

Location Address: **408 N Charles St**

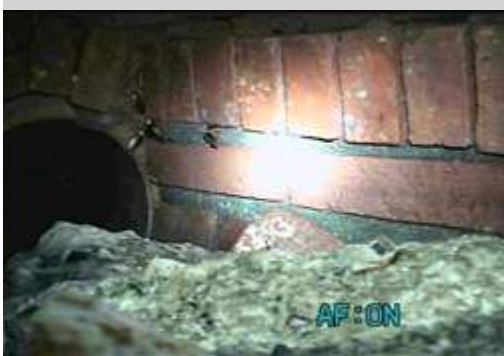
Defect 5

Condition: ☐ Sound ☐ Cracked ☐ Root Intrusion ☐ Deteriorated ☐ Leaks ☒ **Debris**

channel debris

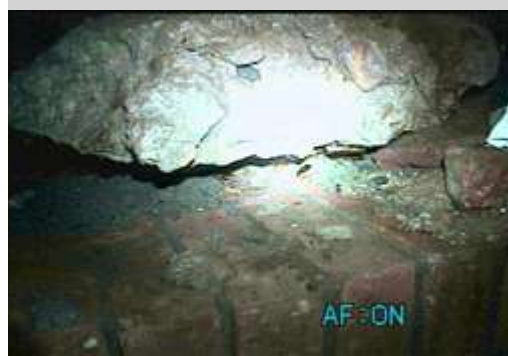
Defect 4

Condition: ☐ Sound ☐ Cracked ☐ Root Intrusion ☐ Deteriorated ☐ Leaks ☒ **Debris**

bench debris

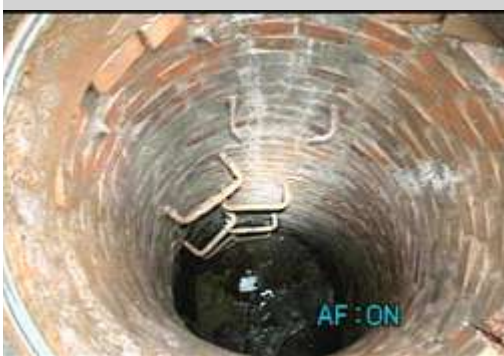
Defect 3

Steps Count: **9** Missing: **2** ☒ **Corroded**

steps

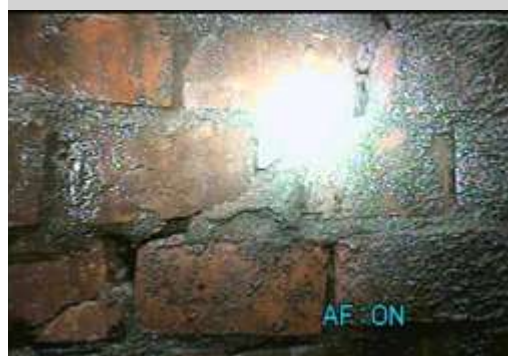
Defect 2

Condition: ☐ Sound ☒ **Cracked** ☐ Root Intrusion ☐ Loose Brick ☐ Deteriorated

cracked corbel

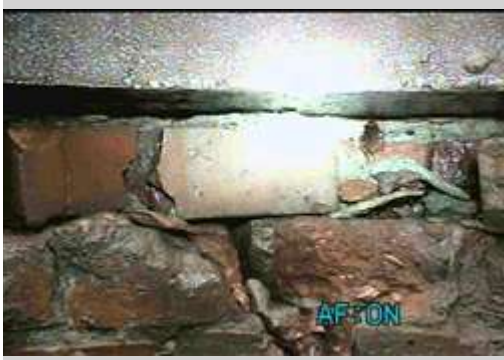
Defect 1

Condition: ☐ Sound ☐ Cracked ☐ Root Intrusion ☒ **Loose Brick** ☒ **Deteriorated**

frame adjustment

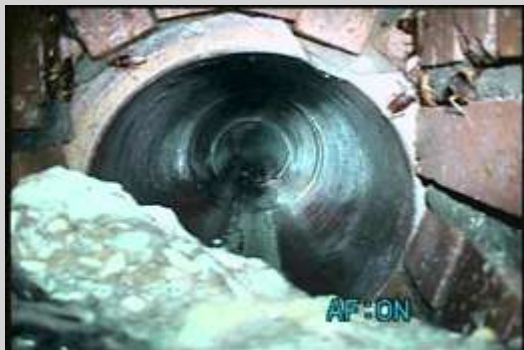
12 O'Clock Outflow

10 in. Circular Gravity Sewer
Pipe Out @ 12 O'Clock

Invert Depth: 14.41 (ft.) Flow Characteristics: Slow

Infiltration: None Pipe Seal Cond: Unknown

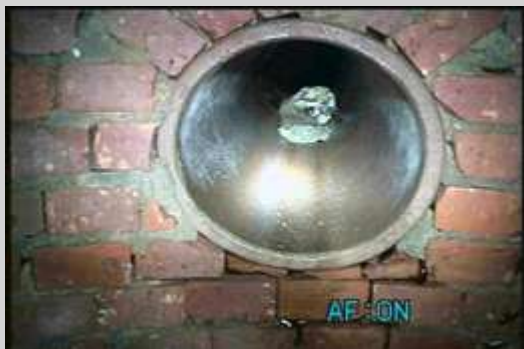
9 O'Clock Inflow

10 in. Circular Gravity Sewer
Pipe In @ 9 O'Clock

Drop In @ 9 O'Clock

Invert Depth: 10.40 (ft.) Flow Characteristics: Slow

Drop: Outside Direct

Drop Condition: Open
